**Subject: Final Removal Action Report
Harper Industries Asbestos Site
Cleveland, Cuyahoga County, Ohio
EPA Contract No. EP-S5-13-01
EPA TDD No. S05-0001-1609-004
Document Tracking No.: 1322**

**FINAL REMOVAL ACTION REPORT
HARPER INDUSTRIES ASBESTOS SITE
CLEVELAND, CUYAHOGA COUNTY, OHIO**

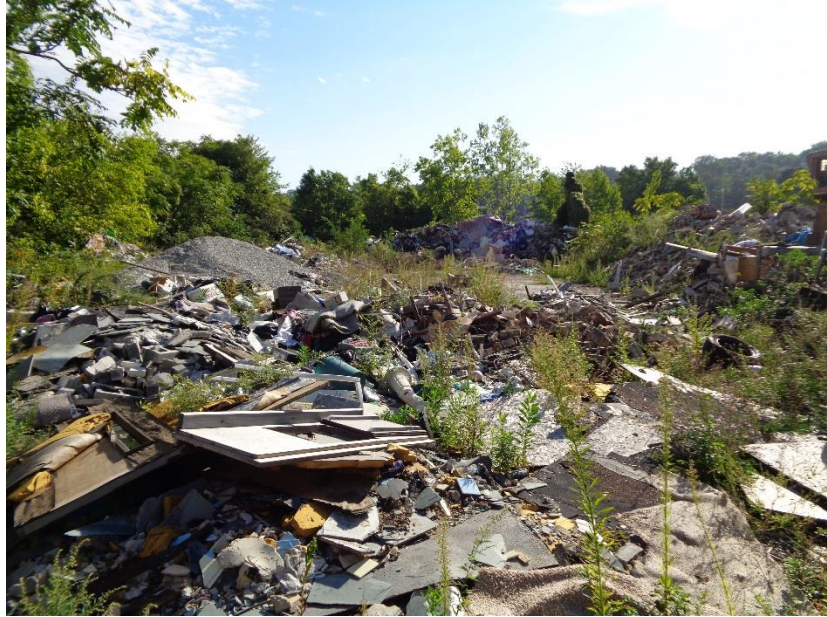
Description:
Debris and municipal waste.

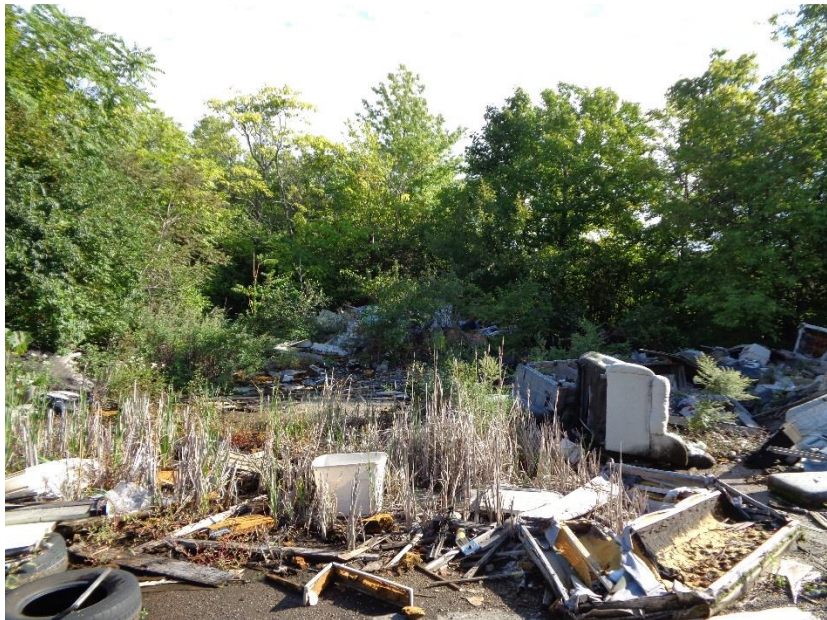
Photograph: 4

Description:
Debris and municipal waste.

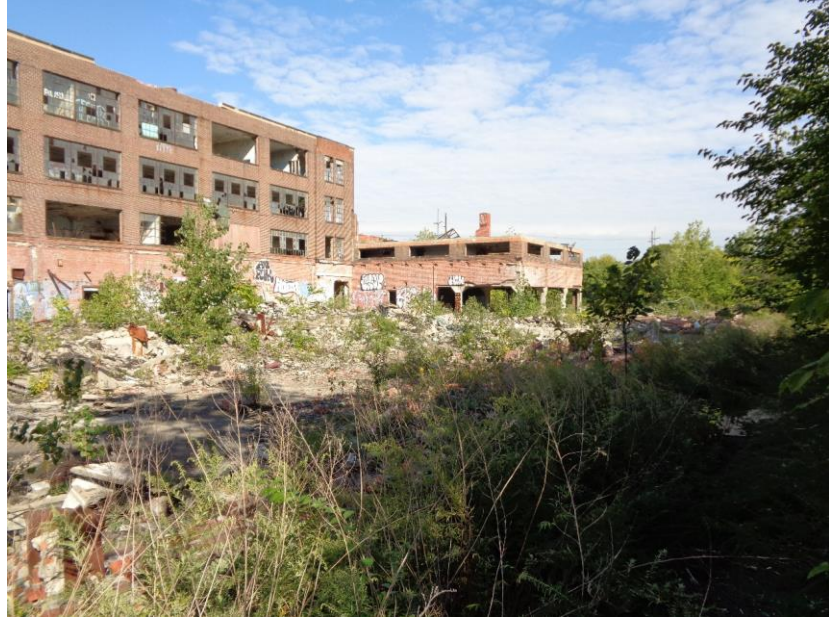
Description:
Debris piles on the eastern side of the building.

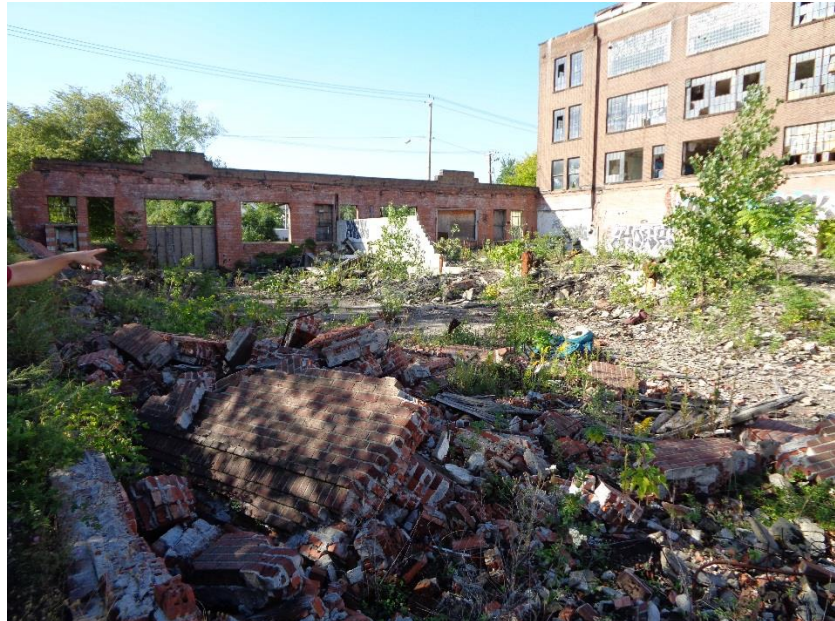
Photograph: 6

Description:
Debris piles on the eastern side of the building.

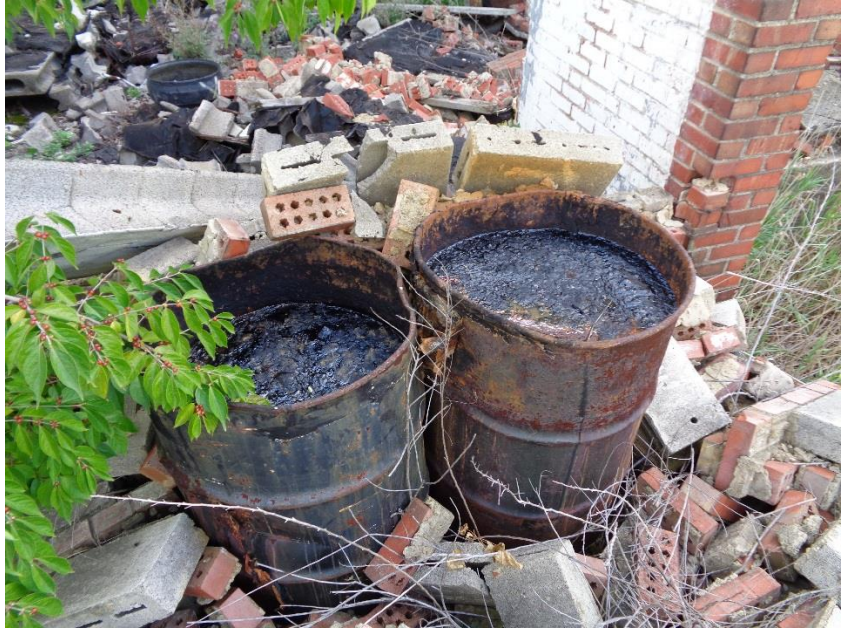
Description:
Two drums of tar-like substance found on the western side of the building.

0750 - GRES HAS OVERPACKED THE TWO WASTE
ROOFING TAR DRUMS INTO TWO DRUMS
LABELED AS 'SOLWAGE DRUM' AND PLACED
OUT OF THE WAY NEAR THE BRICK TRAILER,
ALSO, THE DRUM LABELED 'FUEL OIL POSITIVE'
WAS STARTED LEAKING IN PLACE - WW

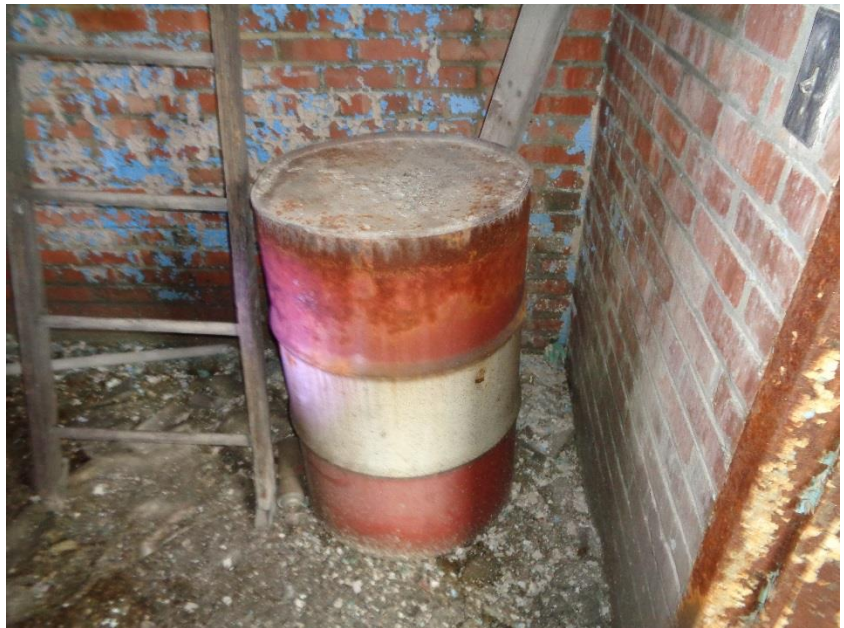
Photograph: 10

Description:
Drum of "fuel oil additive" found inside the building.

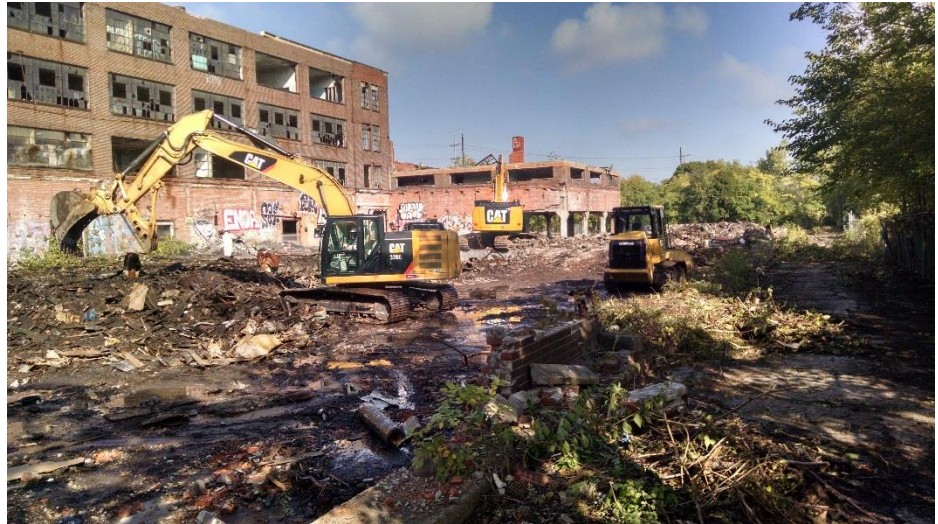
Description:
Asbestos-containing material (ACM) debris being consolidated on the eastern side of the building.

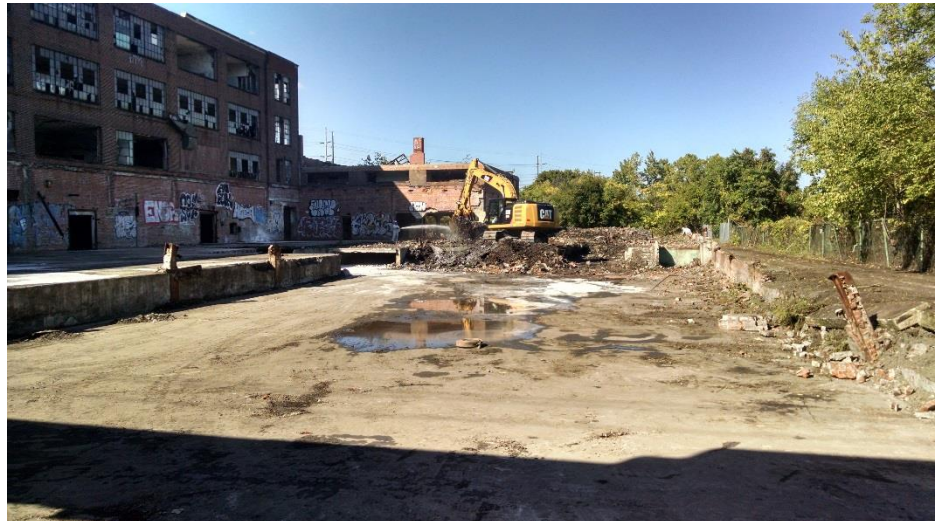
Photograph: 14

Description:
ACM debris being wetted as it is consolidated.

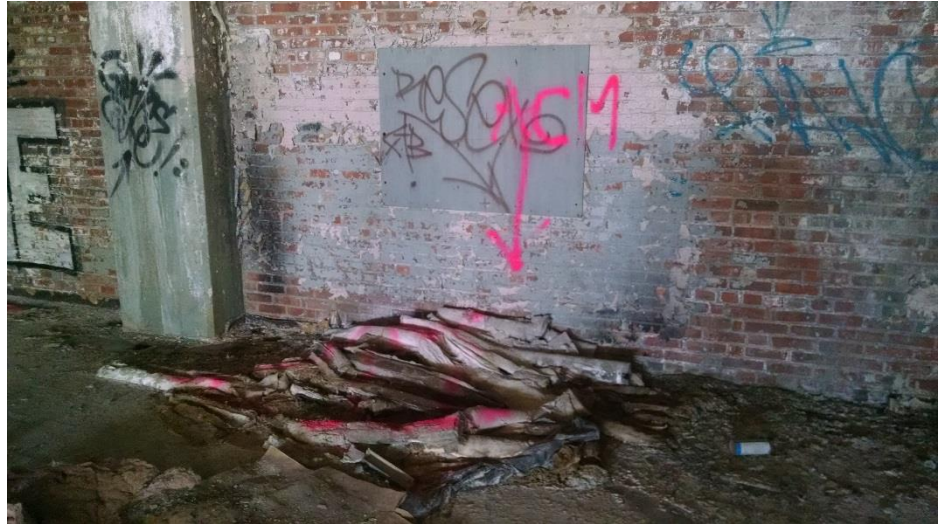
Description:
Example of ACM pipe wrap inside the building.

Inside the former Victoreen Building Complex, all ACWM found on the ground was consolidated, wetted, and double-bagged. A total of 46 bags of loose ACWM, mostly in the form of pipe wrap, were collected and added to the debris pile for disposal.

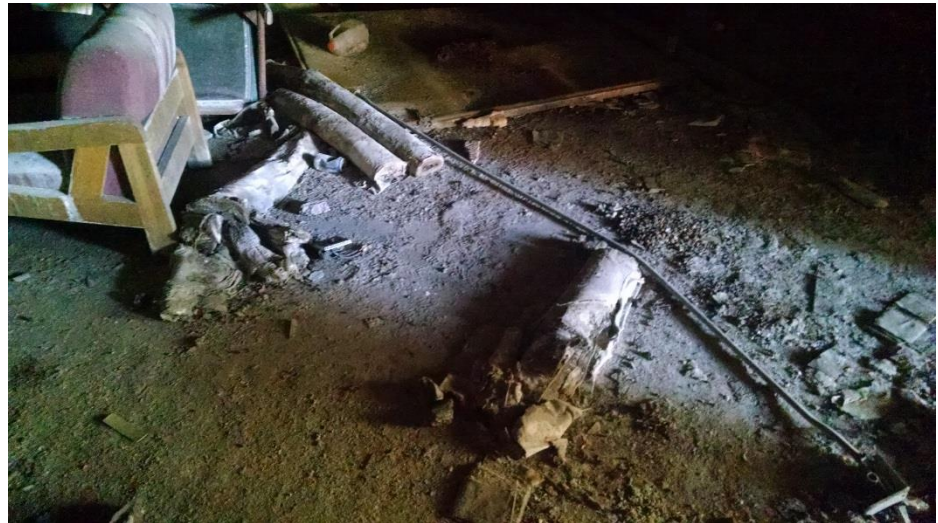
Photograph: 28

Description:
Example of ACM pipe wrap inside the building.

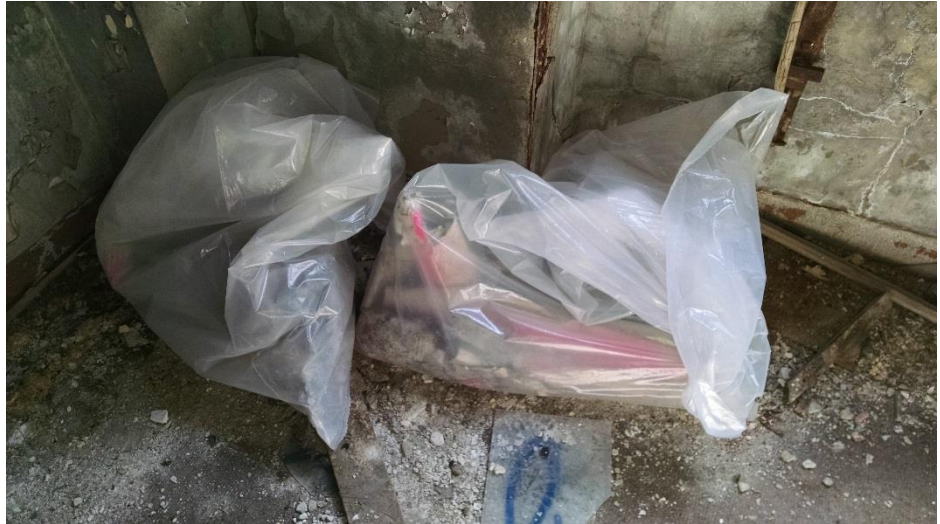
Description:
Bagged ACM pipe wrap.

*BACKNOTE - EDZS COLLECTED 46 BAGS OF PIPE WRAP - LOOSE - FROM UPPER FLOORS (2ND - ROOF). ALL WAS WETTED, THEN DOUBLE BAGGED. BAGS WILL BE DISTRIBUTED EVENLY INTO LINED TRUCKS WHEN BEING LOADED W/ DEBRIS. THIS WAS APPROVED BY THE LANDFILL. WW

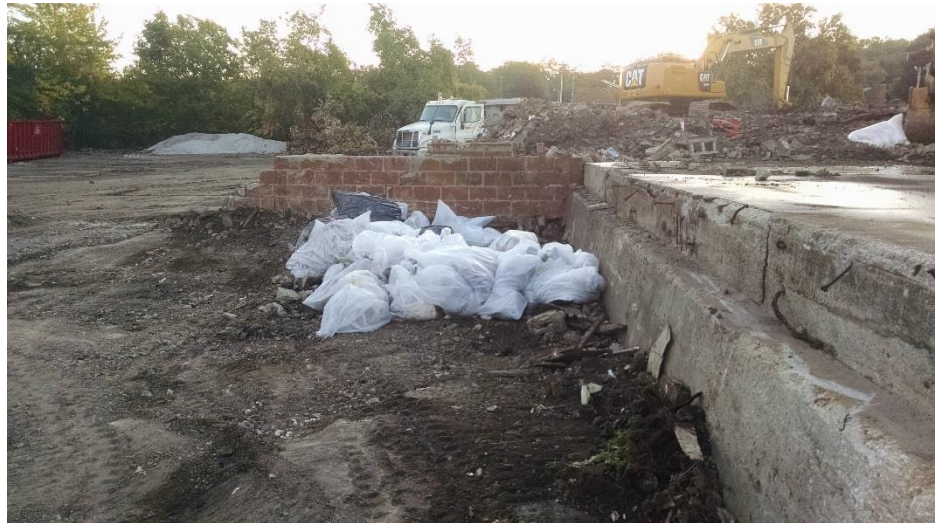
Photograph: 30

Description:
Bagged ACM pipe wrap to be distributed amongst truck loads.

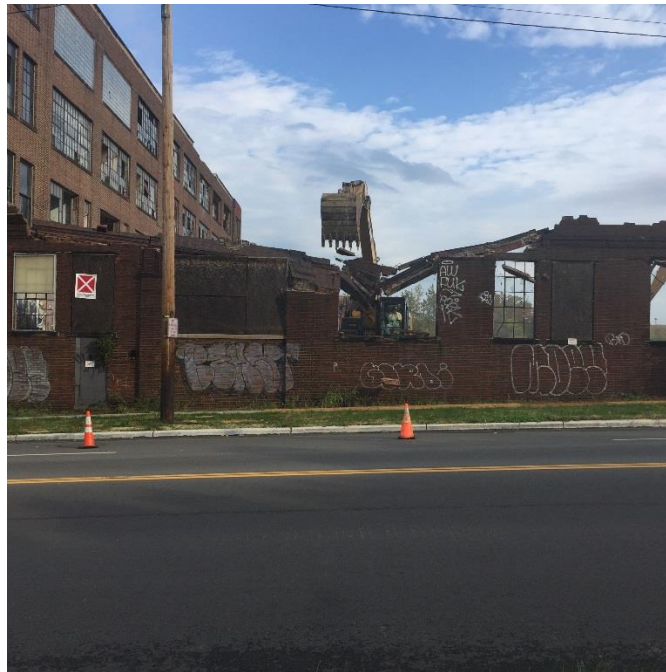
Description:
Wall along Woodland
Avenue being taken
down.

During removal activities, a free-standing wall located at the southeastern corner of the site bordering Woodland Avenue to the north was found to be unstable, posing a public risk. ERRS pulled the wall down and into the site footprint while wetting the debris to deter any fugitive dust. The debris was consolidated into the ACWM pile for removal. A permanent chain-link fence was installed in place of the wall to retain security at the site.

0845 - ERDS BEGINS PULLING THE WALL DOWN
ALONG WOODLAND. ALL GOES WELL, WITH
MINIMAL BRICKS FALLING ONTO THE SIDEWALK
THAT WERE COVERED w/ PLYWOOD. ONE
CRACKED SECTION OCCURRED DUE TO BRICKS
FALLING. ERDS DISCUSSING WHAT TO DO.

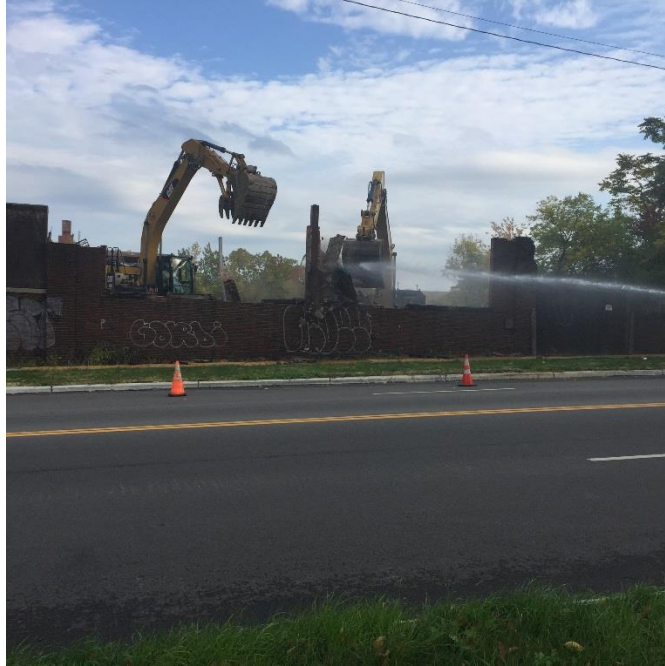
Photograph: 36

Description:
Wall along Woodland Avenue being wetted while taken down.

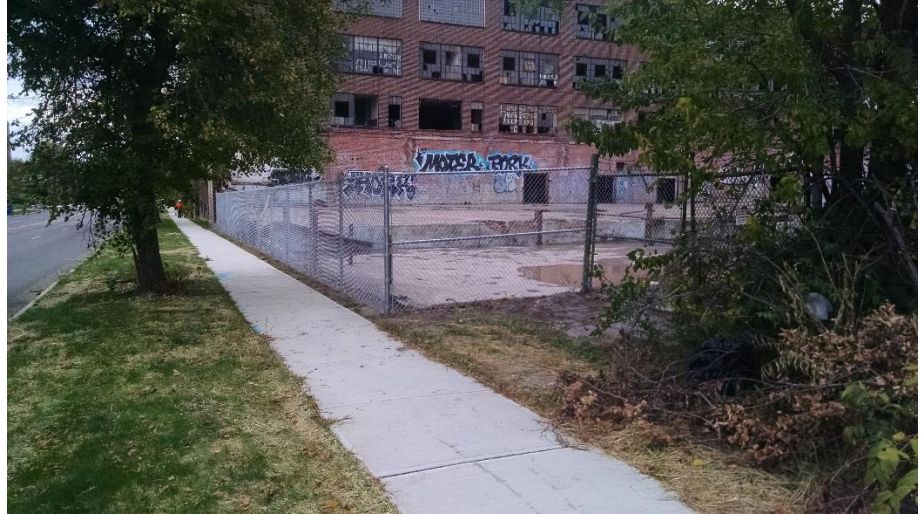
Description:
New permanent fence
where wall was taken
down along Woodland
Avenue.

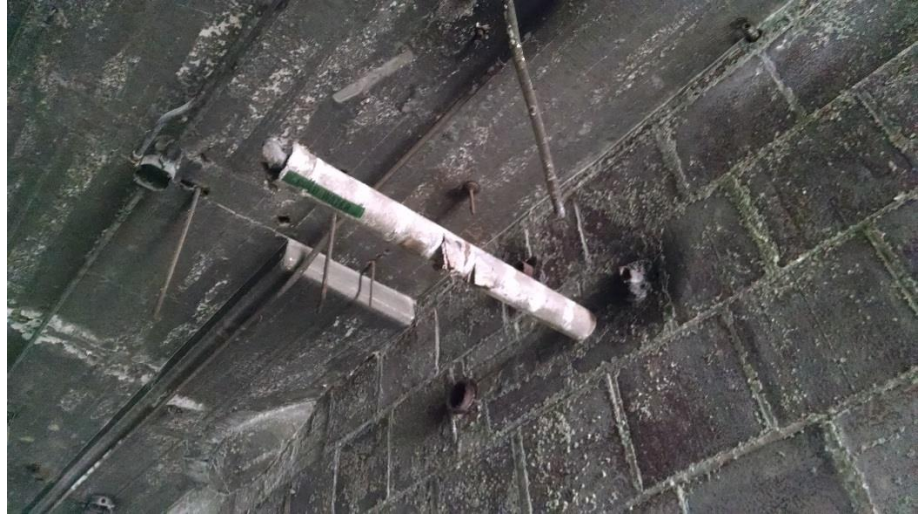
Description:
Example of remaining
ACM pipe wrap in the
building.

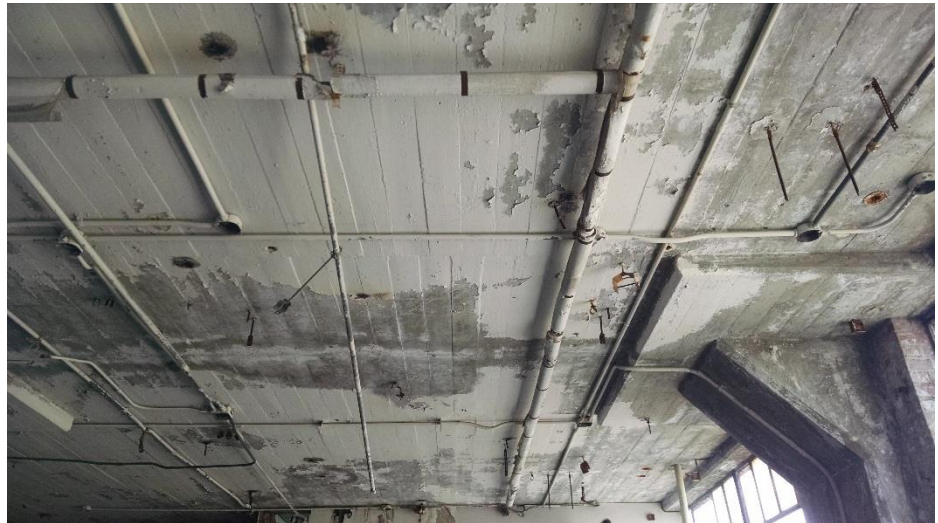
Photograph: 42

Description:
Example of remaining
ACM pipe wrap in the
building.

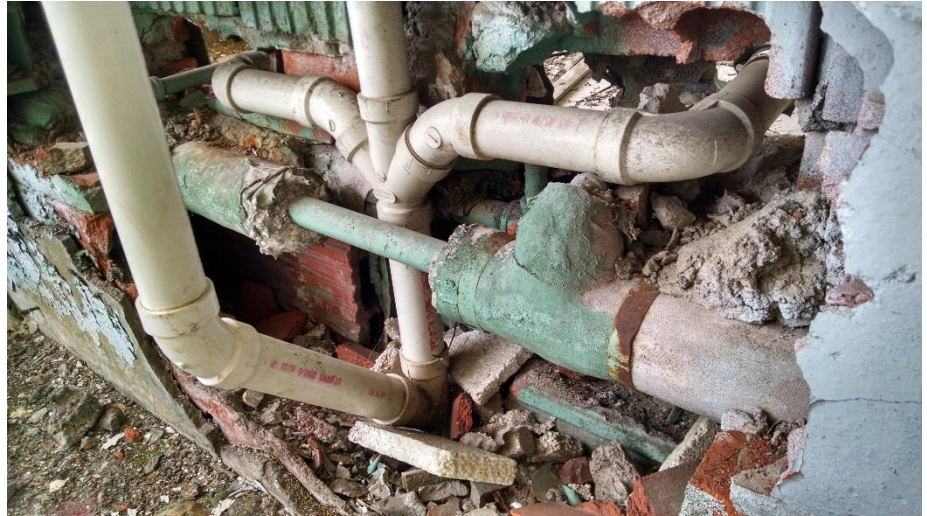
Description:
Example of remaining
ACM pipe wrap in the
building.
